# Inspection Report

**Property Address:**  
1230 Any Street  
Pleasantville FL 99999

**Home Check Inspection Services LLC**

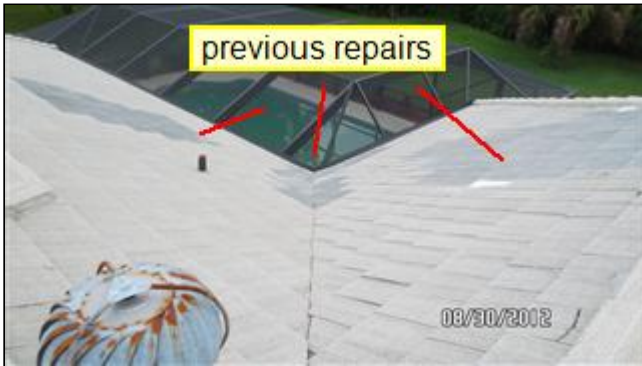
1.0 Picture 1

1.0 There is evidence that the roof has had previous repairs and there are still about a dozen areas that have either cracked tile or tiles that have slid out of position. This is common with tile roofs but I recommend that a licensed roofer repair the various areas in order to prevent future water damage.

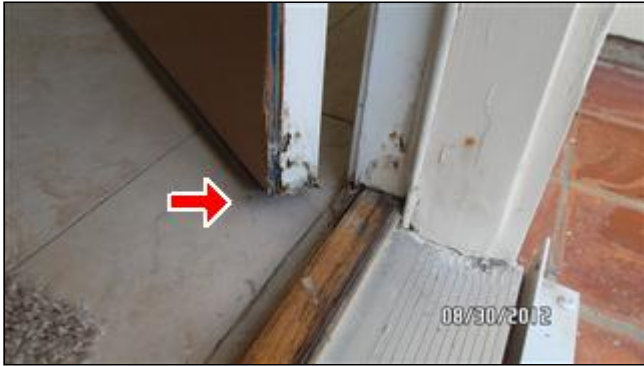
2.1 Picture 1

2.1 There is wood rot at the base of the right front door. This is repairable by a local handy man but if left undone the rot will advance.

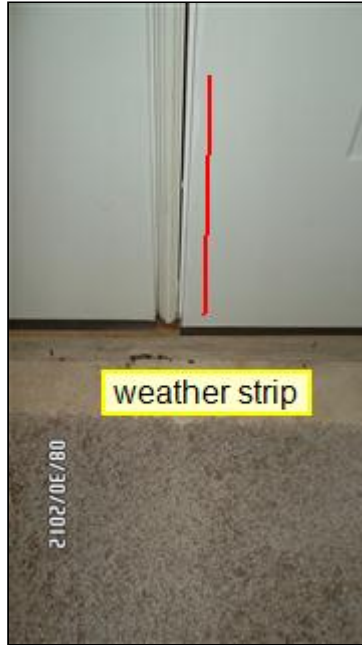
2.1 Picture 2

The weather strip on the front door is not tight which will possibly allow insects to enter. Easily repaired by a handy man.

The sliding door in the master bathroom is not opening and the handle is missing. This door could be an exit in the event of a fire therefore I recommend it be repaired.

The screen door located here is not self closing and should be repaired since it is a safety hazard considering the access to the pool young children being able to enter.

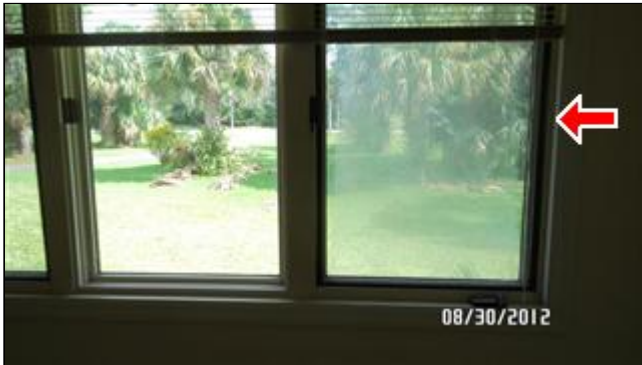
2.2 Picture 1

2.2 There is an insulated window in the master bedroom that is fogged most likely from a broken seal. The consequences are insignificant other than appearance in Florida.

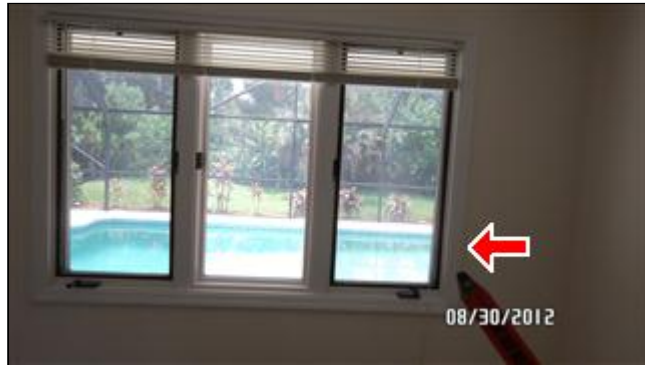
2.2 Picture 2

The right rear window in the master bedroom is not sealing properly on the right side. This possibly will allow insects to enter. This is most likely an easy repair by a handy man.

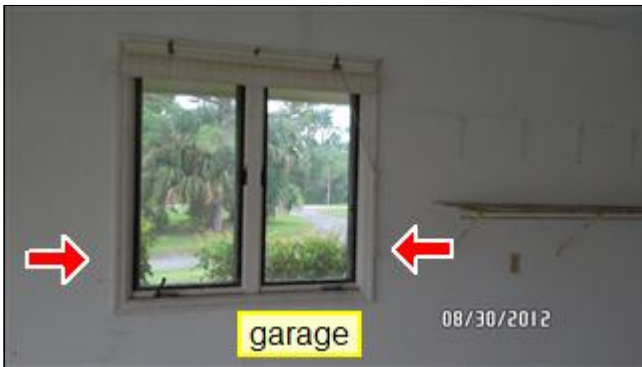
2.2 Picture 3

Both windows in the garage are not working properly or closing.

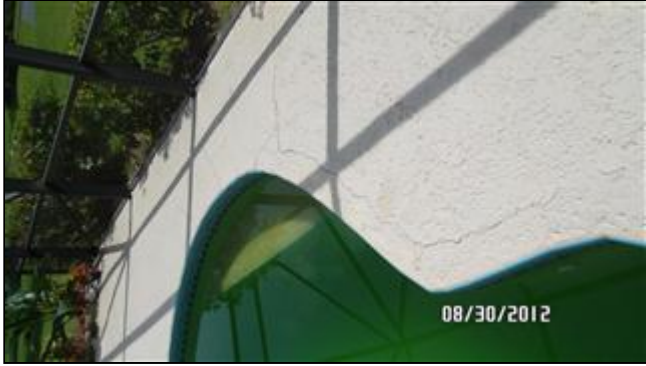
2.3 Picture 1

2.3 There are multiple cracks in the cement patio surrounding the pool and a crack down the pool wall. It is impossible to say if any of these cracks are active or not. I suggest they be patched or painted and observed over time. If they are inactive the deck can be resurfaced and look like new. I spoke with the pool service man while he was there today and he confirmed that without an exhaustive pool inspection it should be watched to determine if you are losing water.

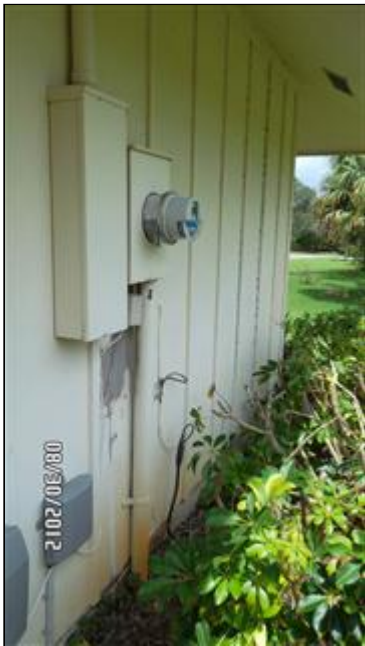
2.4 Picture 1

2.4 Vegetation around the house should not touch the house. The area immediately in front of utilities should be clear 30" wide by 36" deep in order to provide adequate access.

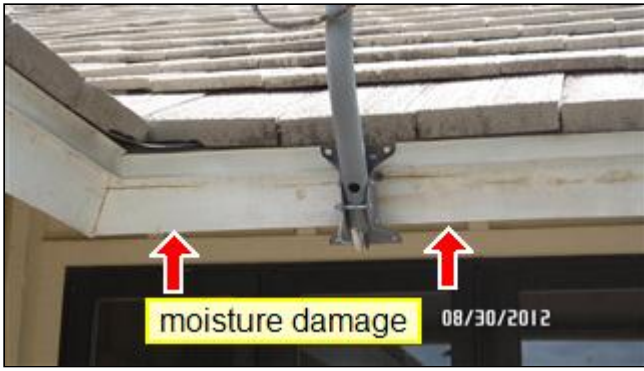
2.5 Picture 1

**2.5** There are several areas where the fascia board is rotted. These are simple repairs for your handy man.

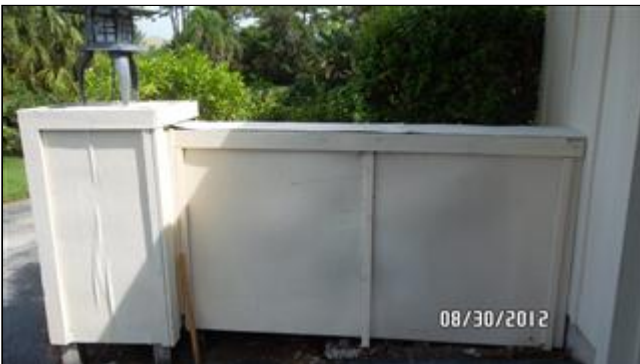
2.6 Picture 1

2.6 The half wall by the garage is rotted and could simply be removed.

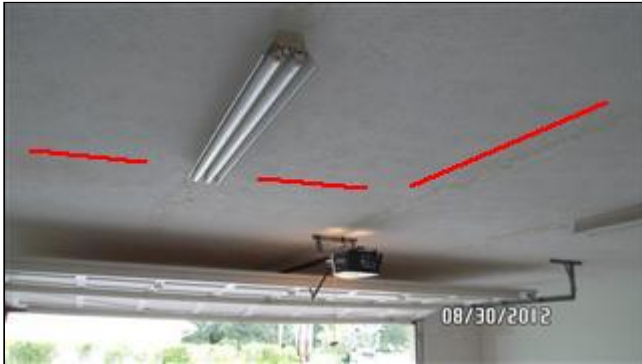
3.0 Picture 1

**3.0** Multiple areas on the ceiling in the garage and throughout the house show signs of attempts to repair where the joint tape has been removed. If you choose to hire a painter he could address these.

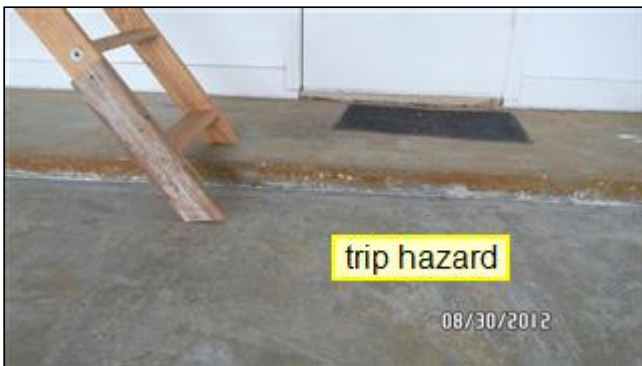
3.2 Picture 1

**3.2** The small rise in the garage floor is a trip hazard that should be highlighted by paint in my opinion.

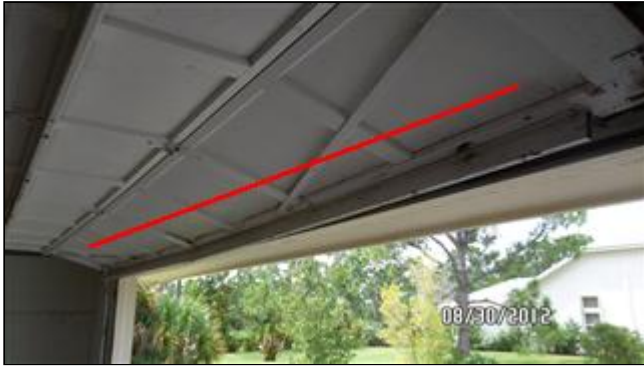
3.3 Picture 1

3.3 The garage door has moisture damage on the lowest panel in particular but the door could still provide several years of service.

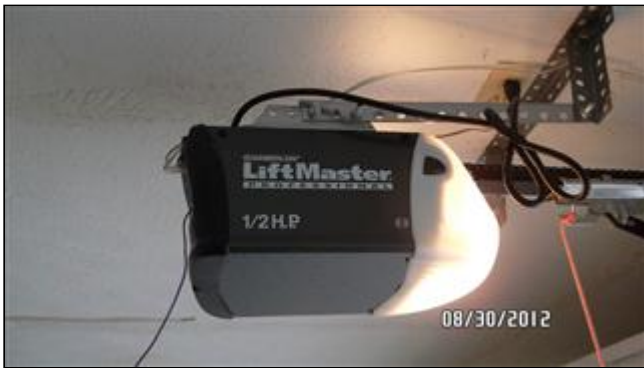
3.5 Picture 1

3.5 The garage door opener functional properly but the lock on the right side facing out was troublesome.

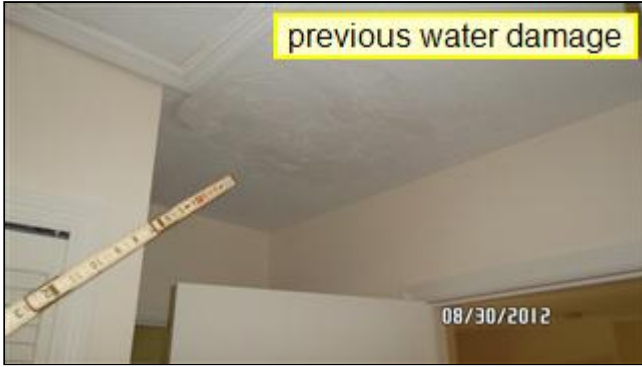
4.0 Picture 1

4.0 The ceilings showed signs of previous water damage and repairs. There were other areas repaired from removing various fixtures.

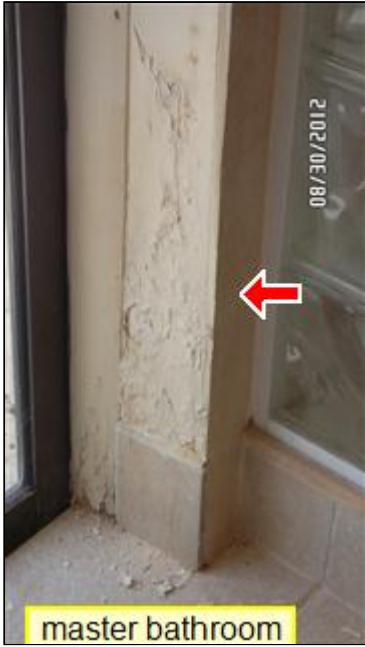
4.1 Picture 1

4.1 For the most part the walls were in pretty good condition and most flaws will be repaired by a painter. This area in the master bathroom showed a repair from a previous leak most likely from the roof.

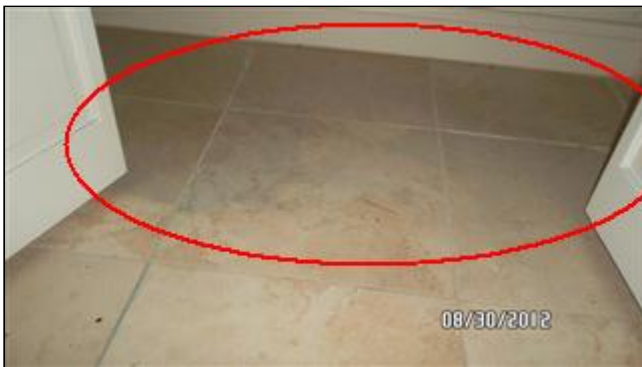
4.2 Picture 1

4.2 There appears to be a large stain or spill in the foyer closet.

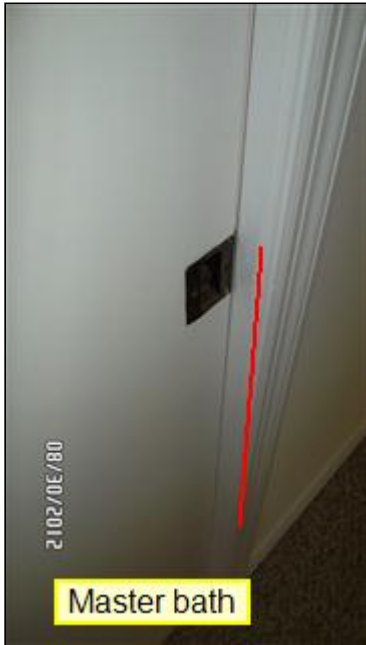
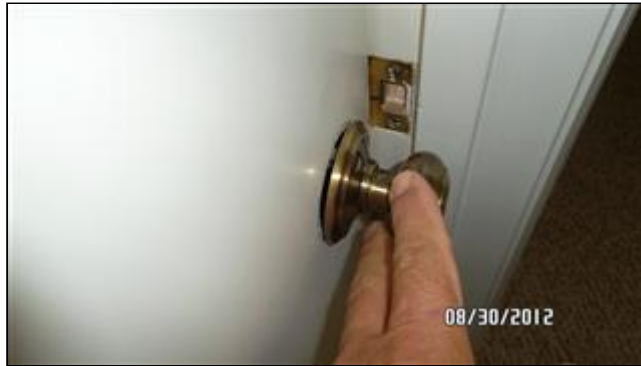
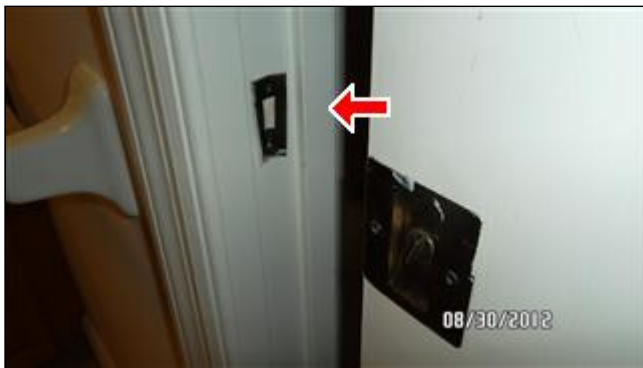
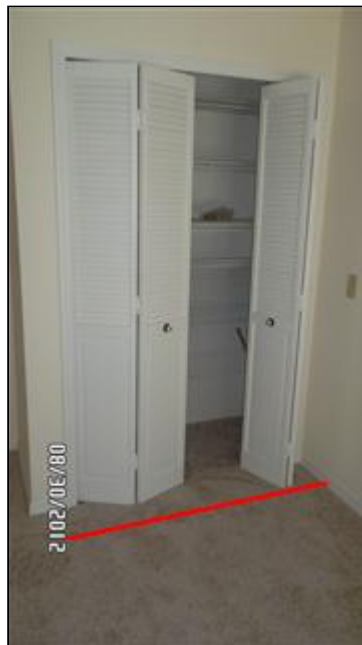
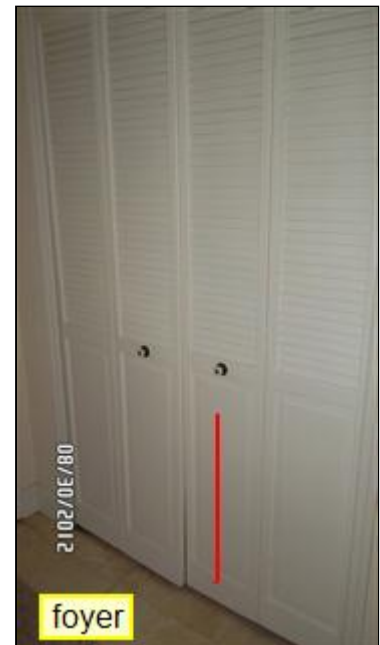
The door knob to the master closet is loose.

The carpet is preventing the cabana closet door from functioning. The door simply needs to be raised or shortened.

There is a twisted door in the foyer preventing it from shutting properly.

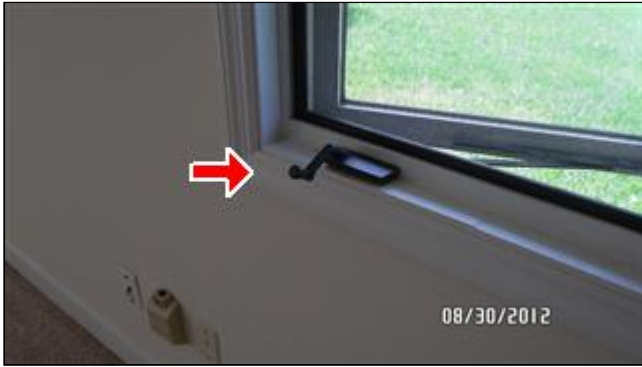
4.6 Picture 1

4.6 As previously mentioned several windows are not working properly.

The window crank in the dining room need to be re-secured.

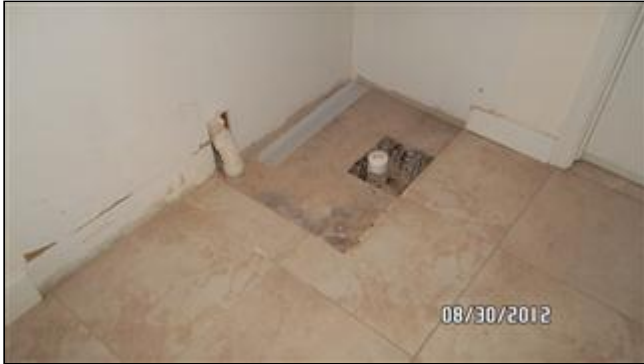
6.0 Picture 1

6.0 There is an area that may have been used for the hot water tank prior to having the garage built in 2000. This is unsightly but could be covered or filled.

There should be a raised area in the dishwasher drain line above the disposal to prevent contaminated water from re-entering the dishwasher.

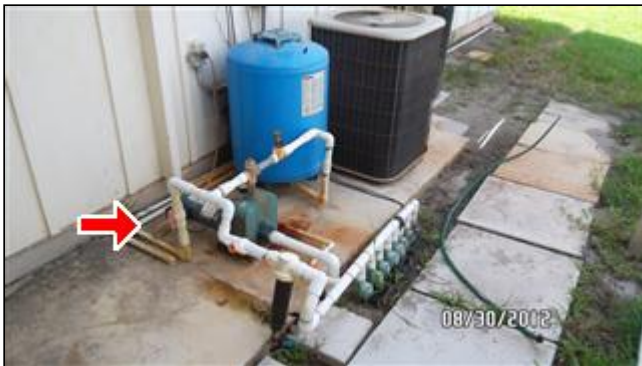
6.5 Picture 1

6.5 The main water shut off valve is at the well.

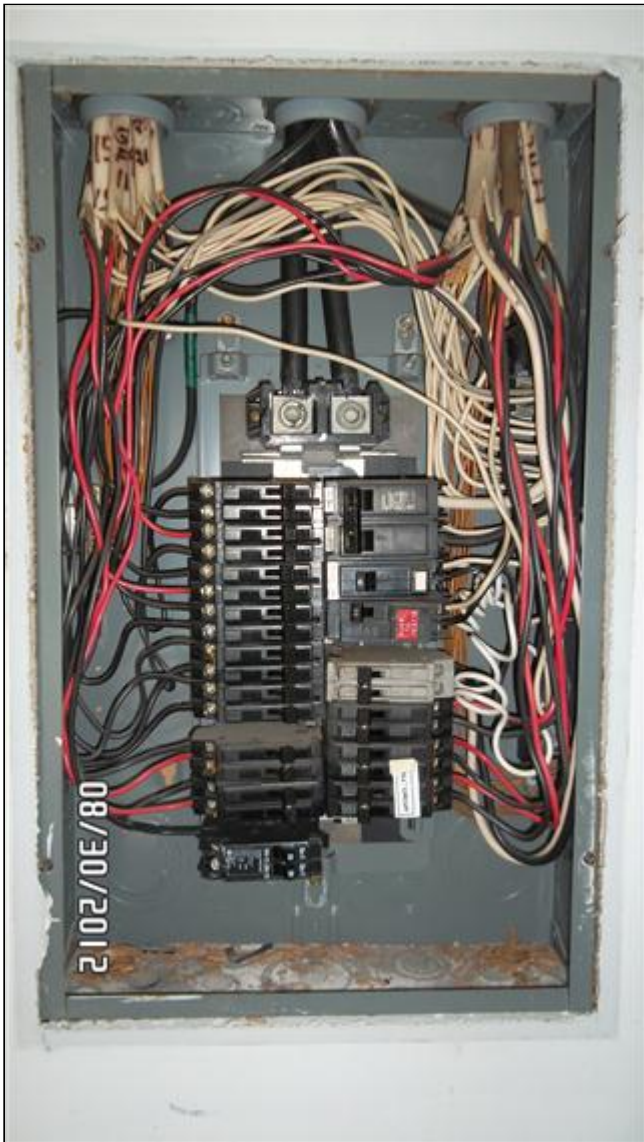
7.1 Picture 1

7.1 Review the Four point inspection regarding the Sylvania sub-panel

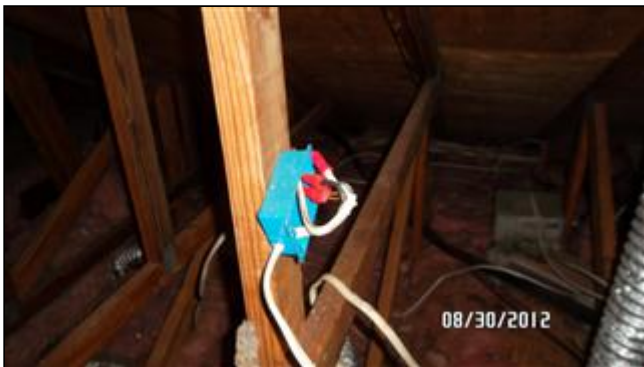
7.2 Picture 1

7.2 There are multiple junction boxes that are not covered in the attic. For safety purposes these should be covered.

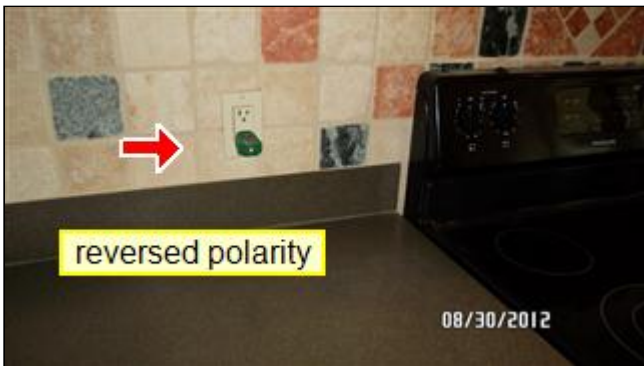
7.4 Picture 1

7.4 Outlet next to the range is reversed polarity so a GFCI will not work even if installed.

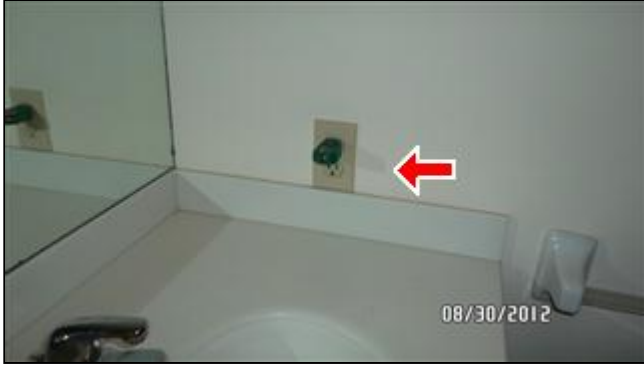
7.5 Picture 1

7.5 There are numerous duplex outlets both inside and out that are not protected by GFCIs. This is a shock hazard and should be addressed by a licensed electrician. Of particular note are the ones in the two bathrooms which have a GFI breaker in the garage and it works in the garage but not in the bathrooms because the outlets are wired improperly. Kitchen outlets are not protected either.

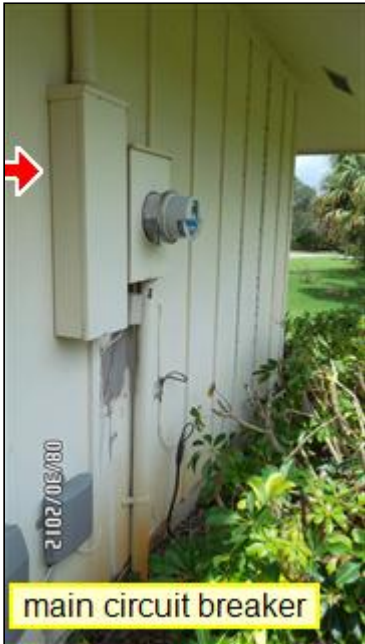
7.6 Picture 1

7.6 The main circuit breaker shut off

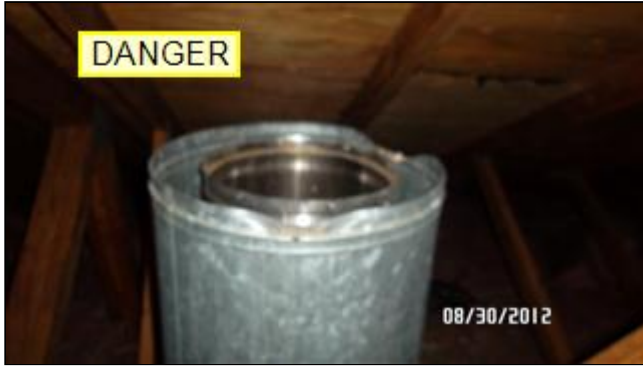
8.4 Picture 1

8.4 The gas fireplace chimney is not finished and is dumping into the attic which created a serious fire hazard. I suggest you remove the fireplace since the roof has been repaired.

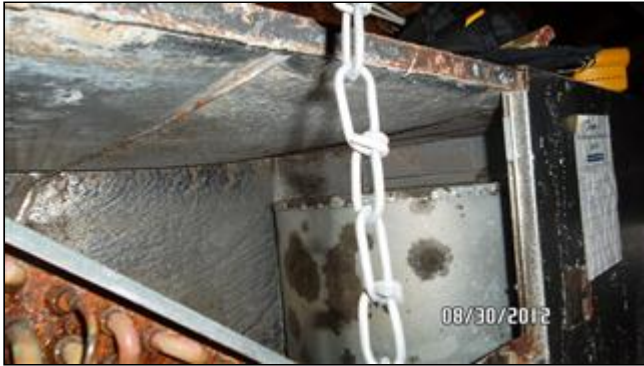
8.7 Picture 1

8.7 The A/C system as a whole is at the end of its life expectancy. You may wish to have the air handler cleaned since it appears to have been neglected for some time. There is also only about a 6 degree temperature differential between intake and output temperatures. I recommend you have at least one more servicing of the system if you plan to use it for a while.

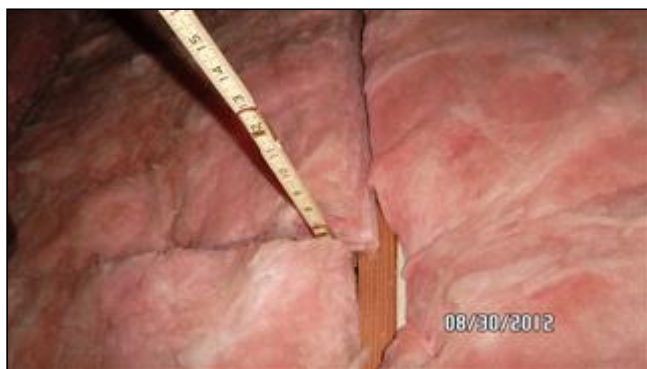
9.0 Picture 1

**9.0** There is R19 insulation in the attic but a few spots have voids.

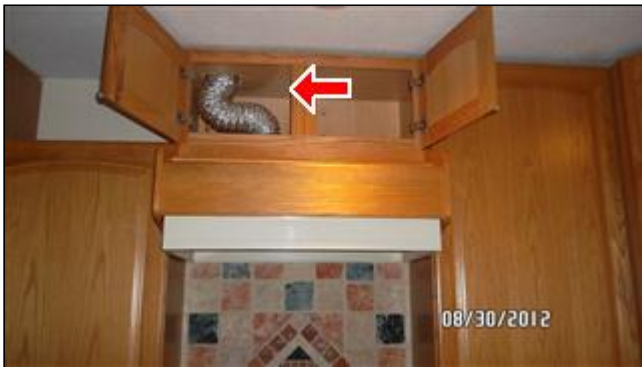
10.2 Picture 1

**10.2** The range hood vent is not vented to the exterior, it is dumping moisture into the attic which will promote mold and moisture damage. I suggest you either not use it or have it vented properly.

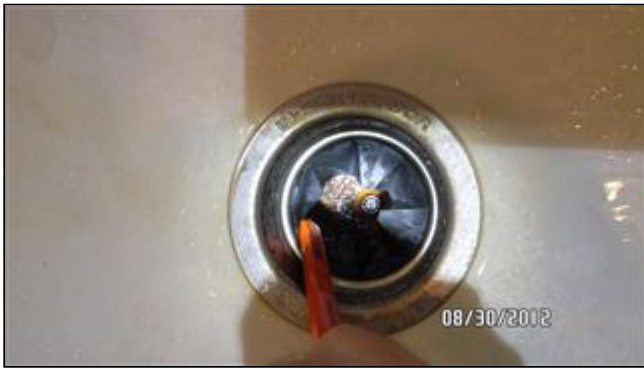
10.4 Picture 1

10.4 The food waste disposer is heavily rusted and has a minor leak in the mounting.

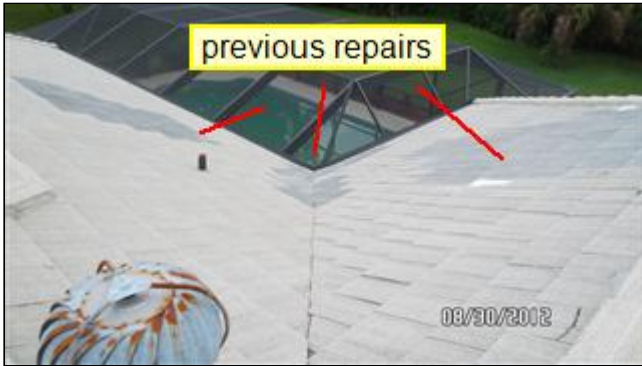
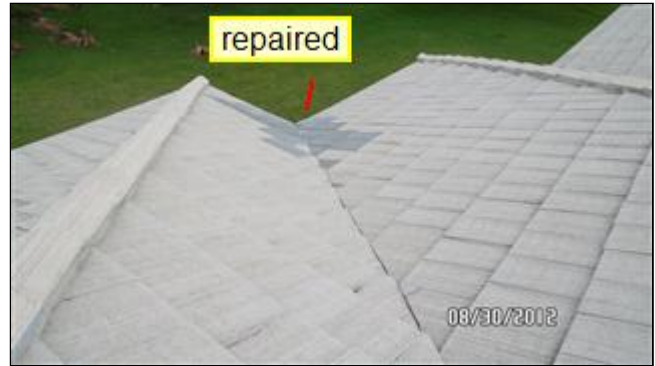
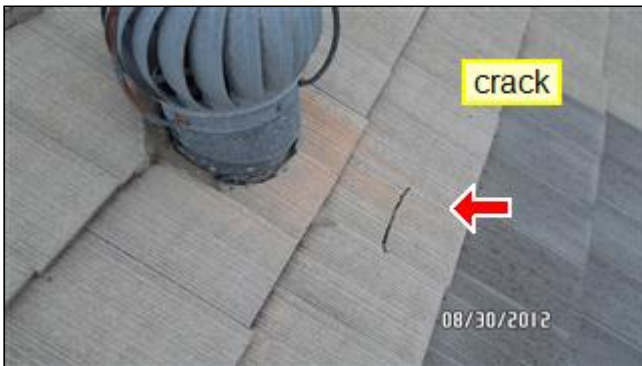
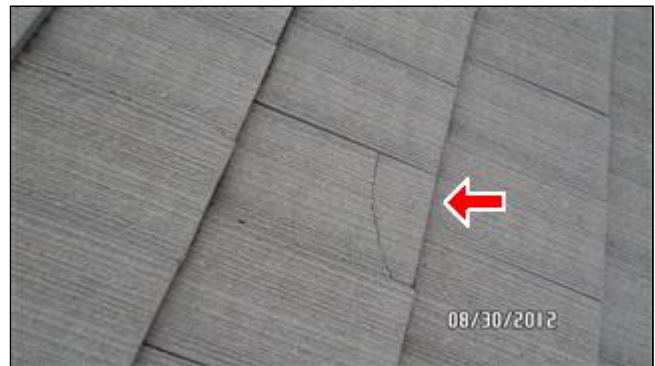
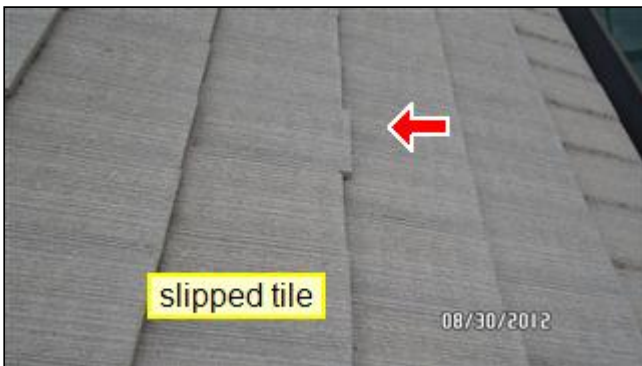
There is evidence that the roof has had previous repairs and there are still about a dozen areas that have either cracked tile or tiles that have slid out of position. This is common with tile roofs but I recommend that a licensed roofer repair the various areas in order to prevent future water damage.

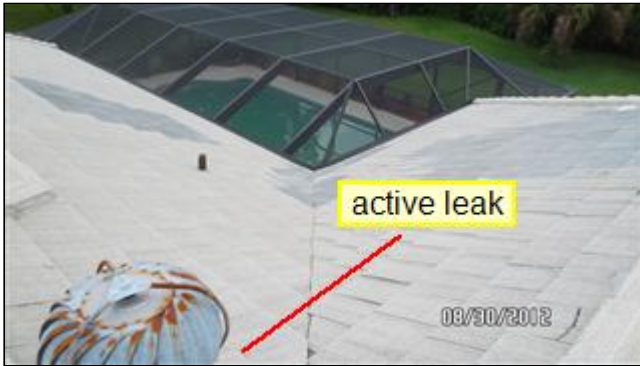
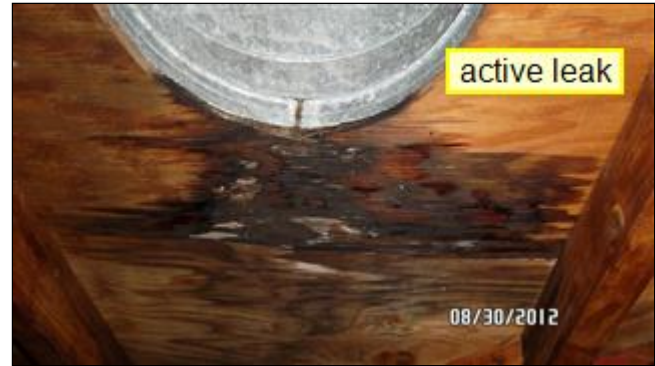
The flashing around this vent is leaking and causing water damage. I recommend a licensed roofer address this area immediately. Fortunately it was raining hard just prior to my inspecting the attic. Other than this leak I saw no others.

As noted above the vent opening is in need of repair.

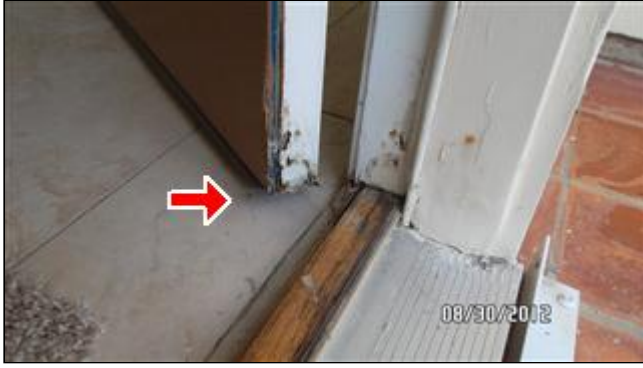
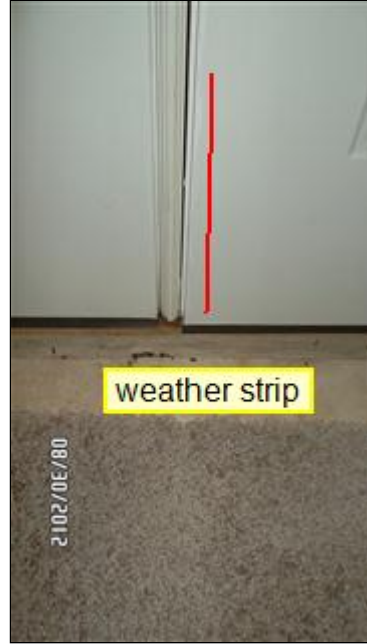
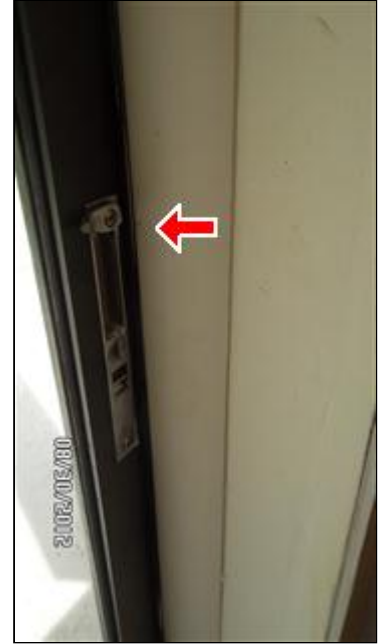
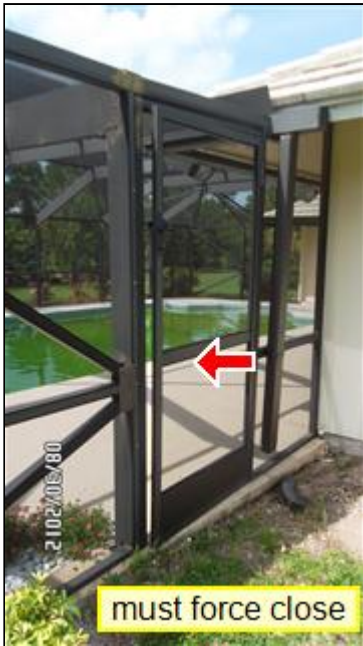
There is wood rot at the base of the right front door. This is repairable by a local handy man but if left undone the rot will advance.

The weather strip on the front door is not tight which will possibly allow insects to enter. Easily repaired by a handy man.

The sliding door in the master bathroom is not opening and the handle is missing. This door could be an exit in the event of a fire therefore I recommend it be repaired.

The screen door located here is not self closing and should be repaired since it is a safety hazard considering the access to the pool young children being able to enter.

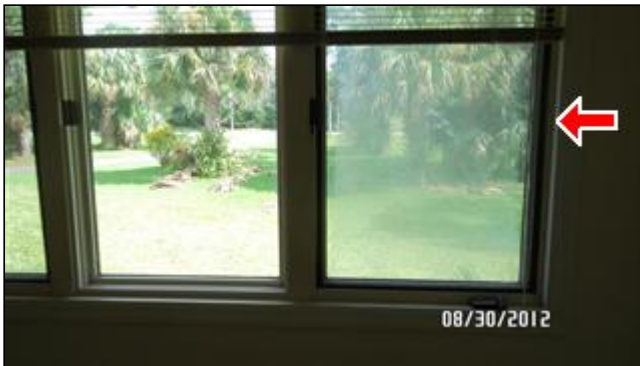
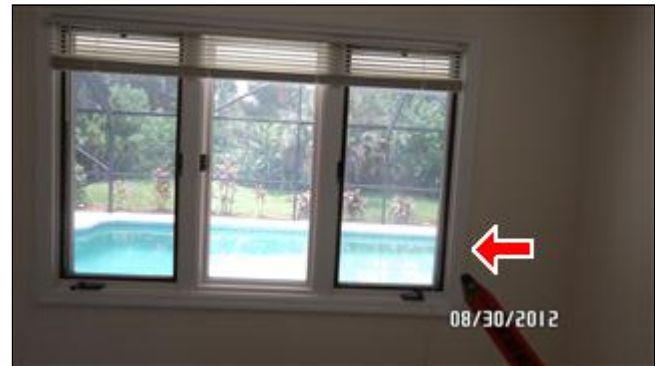
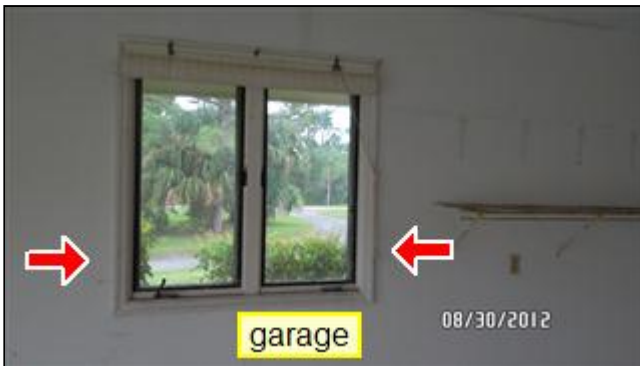
There is an insulated window in the master bedroom that is fogged most likely from a broken seal. The consequences are insignificant other than appearance in Florida.

The right rear window in the master bedroom is not sealing properly on the right side. This possibly will allow insects to enter. This is most likely an easy repair by a handy man.

Both windows in the garage are not working properly or closing.

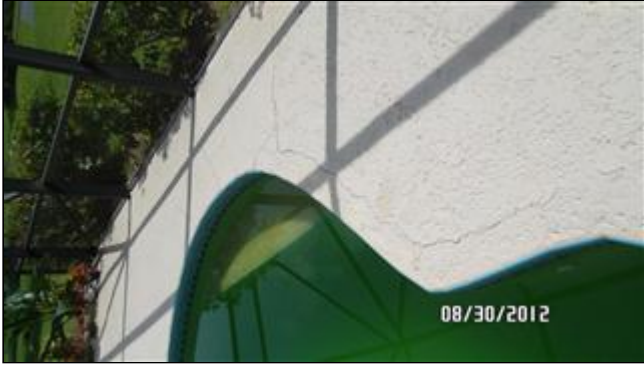
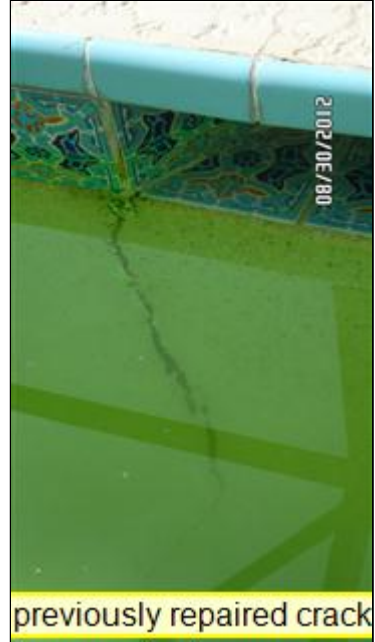
There are multiple cracks in the cement patio surrounding the pool and a crack down the pool wall. It is impossible to say if any of these cracks are active or not. I suggest they be patched or painted and observed over time. If they are inactive the deck can be resurfaced and look like new. I spoke with the pool service man while he was there today and he confirmed that without an exhaustive pool inspection it should be watched to determine if you are losing water.

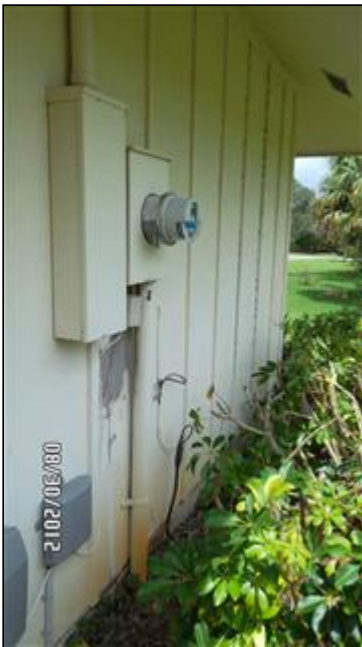
2.4 Picture 1

Vegetation around the house should not touch the house. The area immediately in front of utilities should be clear 30" wide by 36" deep in order to provide adequate access.

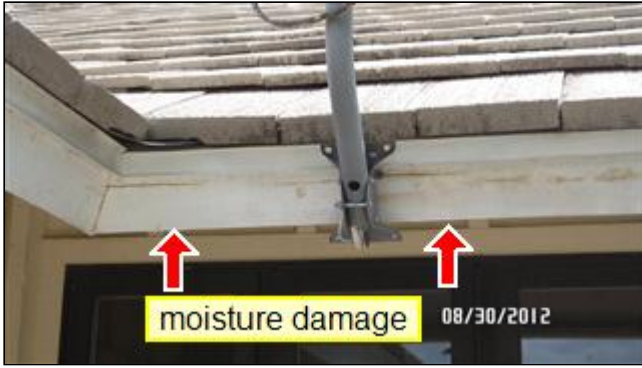
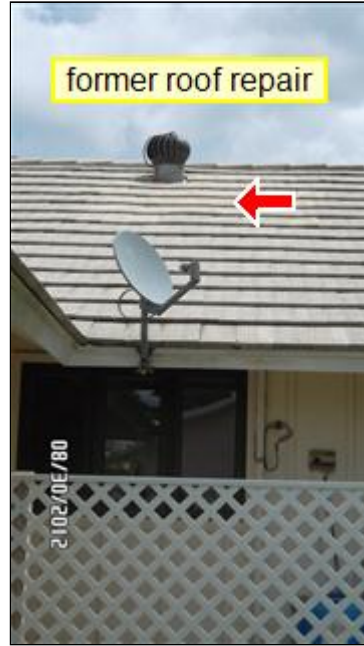
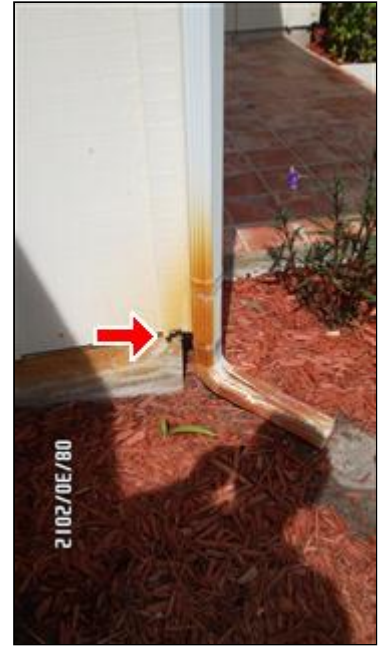
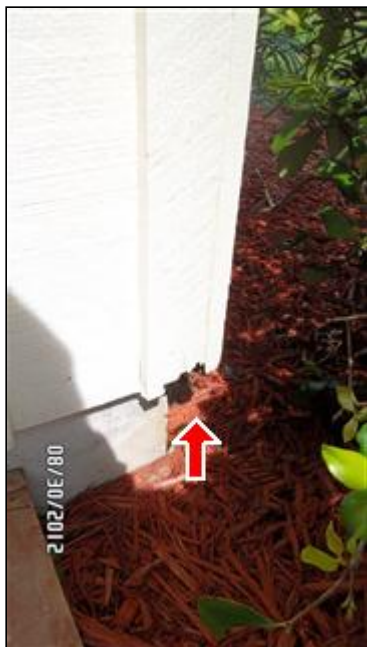
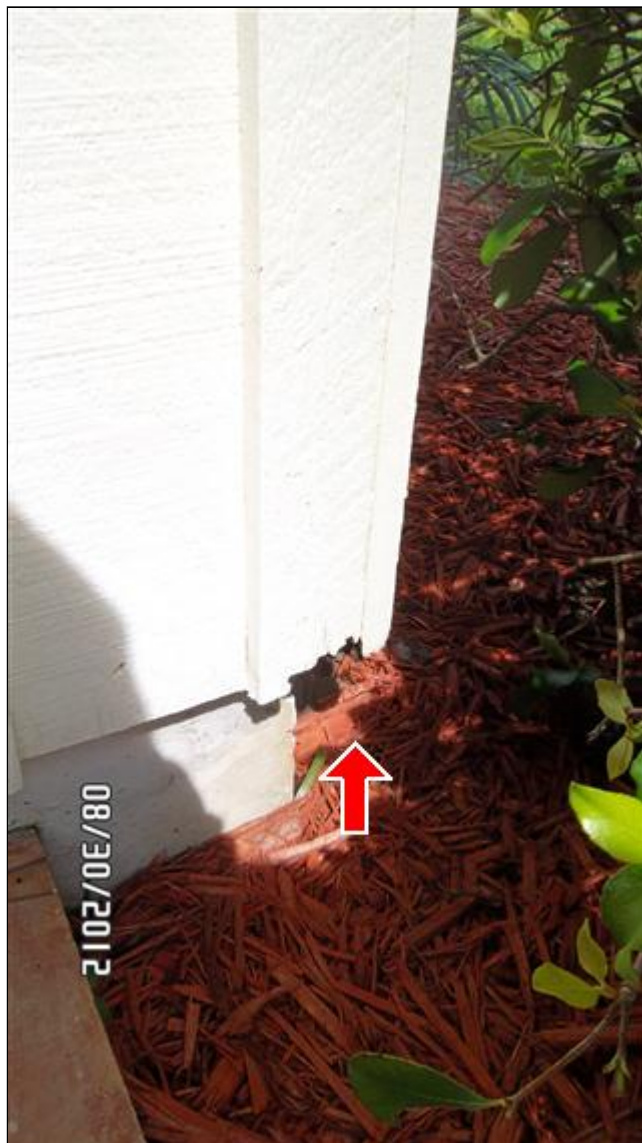
There are several areas where the fascia board is rotted. These are simple repairs for your handy man.

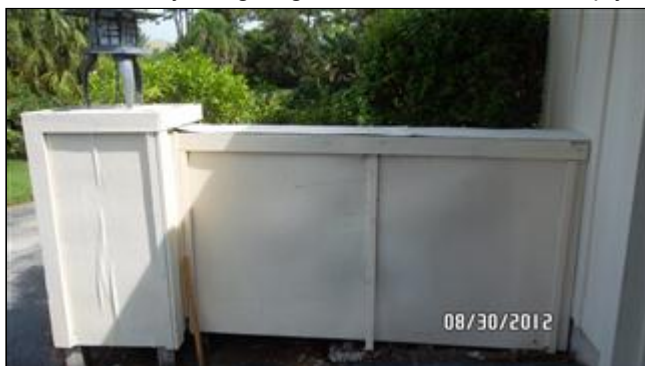
2.6 Picture 1

The half wall by the garage is rotted and could simply be removed.

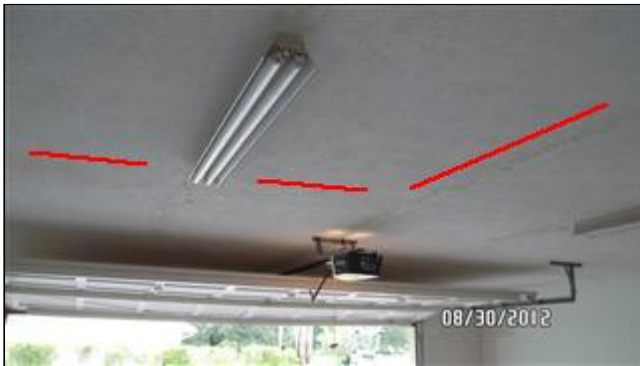
3.0 Picture 1

Multiple areas on the ceiling in the garage and throughout the house show signs of attempts to repair where the joint tape has been removed. If you choose to hire a painter he could address these.

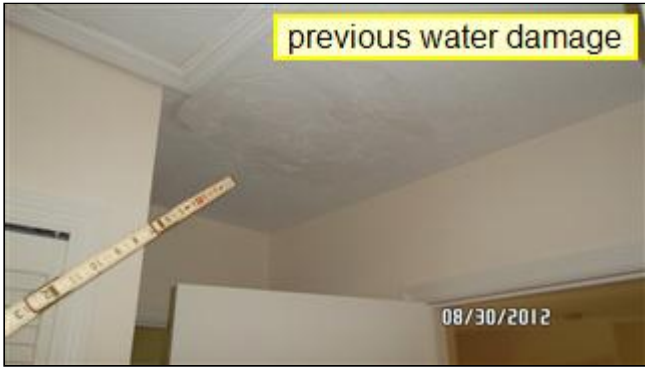
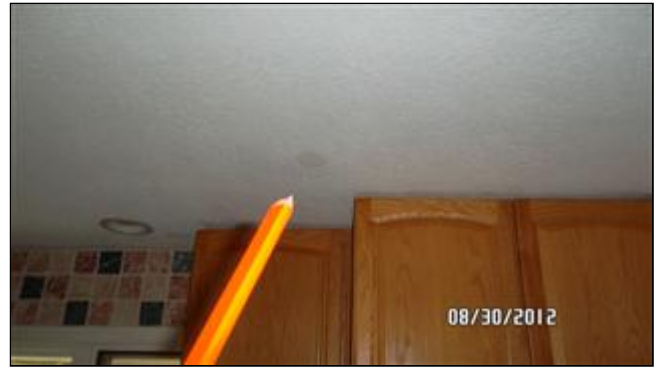
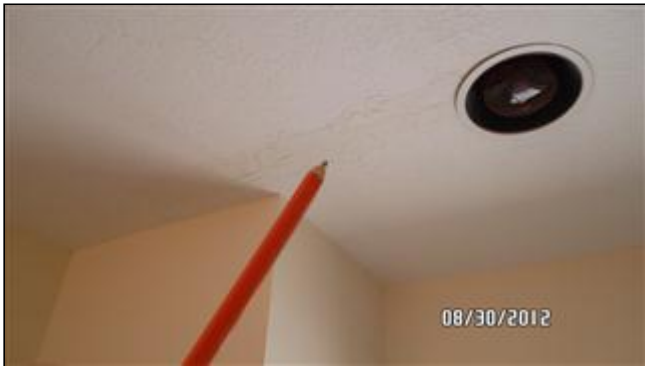
The ceilings showed signs of previous water damage and repairs. There were other areas repaired from removing various fixtures.

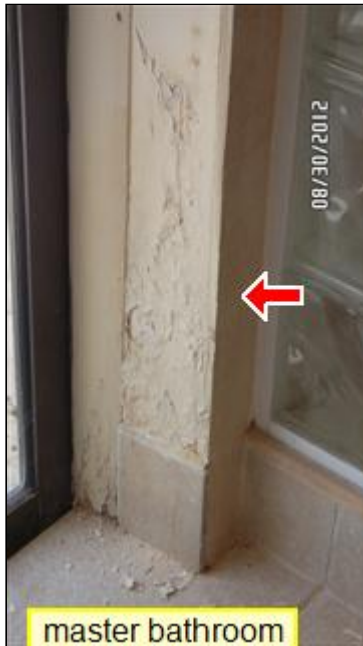
4.1 Picture 1

For the most part the walls were in pretty good condition and most flaws will be repaired by a painter. This area in the master bathroom showed a repair from a previous leak most likely from the roof.

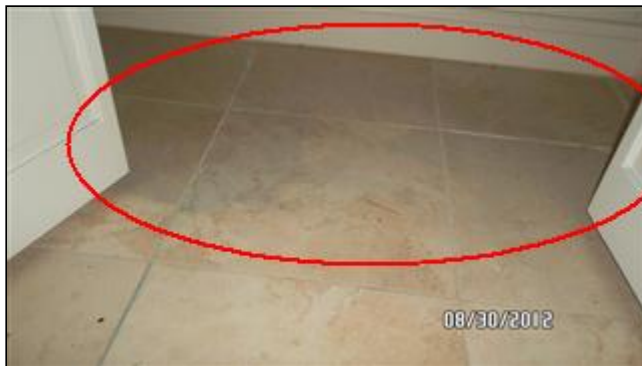
4.2 Picture 1

There appears to be a large stain or spill in the foyer closet.

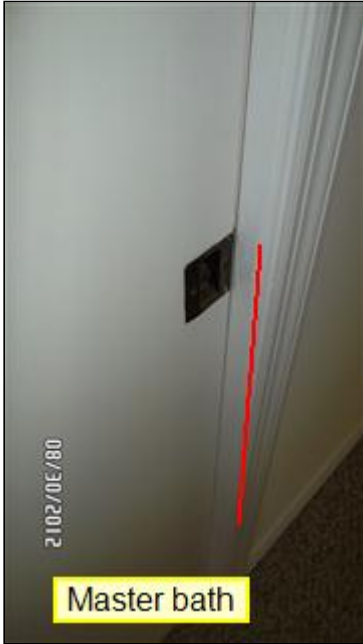
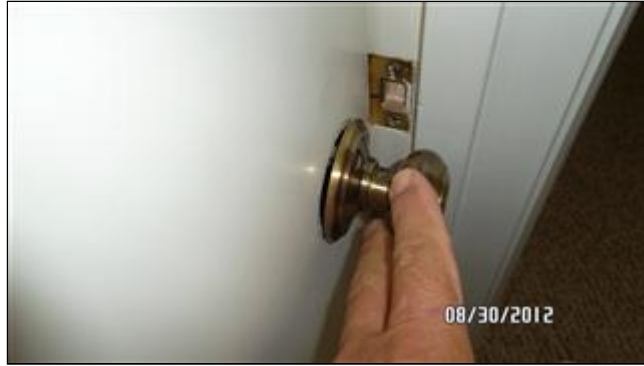
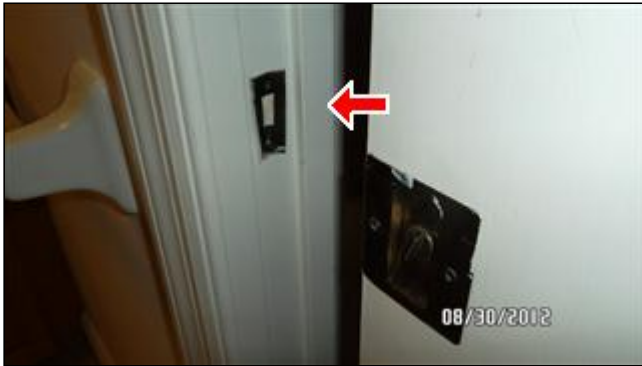
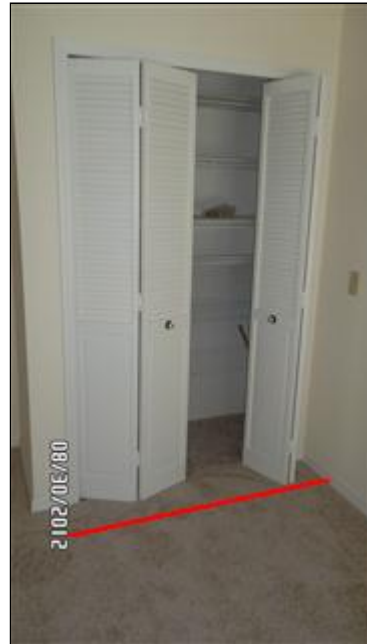
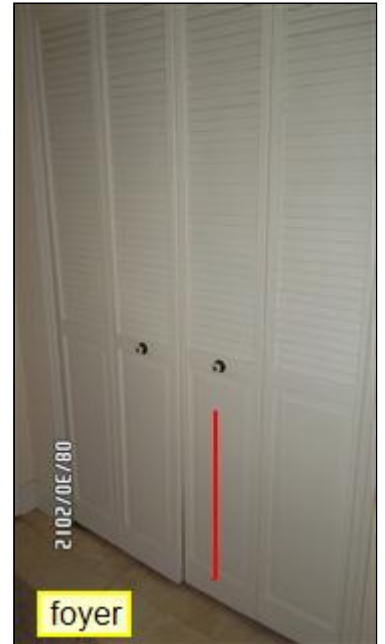
The door knob to the master closet is loose.

There is a twisted door in the foyer preventing it from shutting properly.

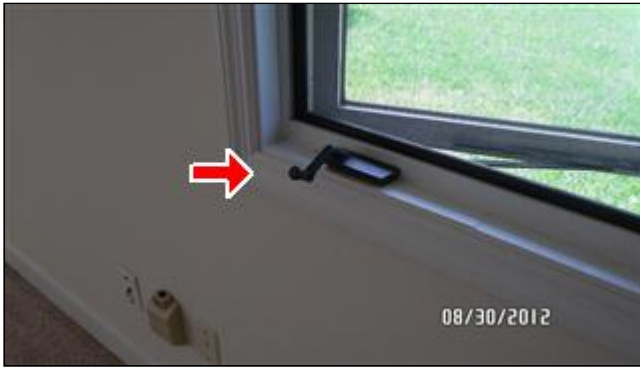
4.6 Picture 1

The window crank in the dining room need to be re-secured.

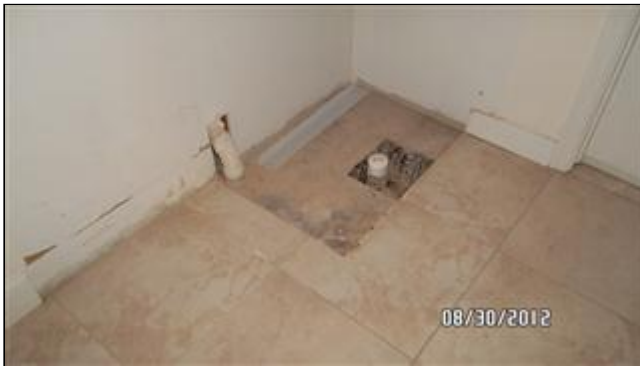
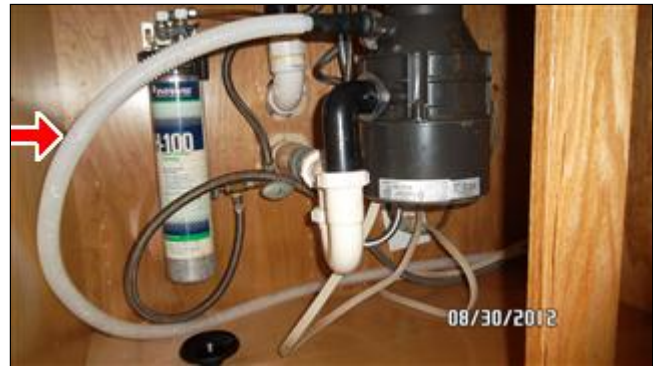
There is an area that may have been used for the hot water tank prior to having the garage built in 2000. This is unsightly but could be covered or filled.

There should be a raised area in the dishwasher drain line above the disposal to prevent contaminated water from re-entering the dishwasher.

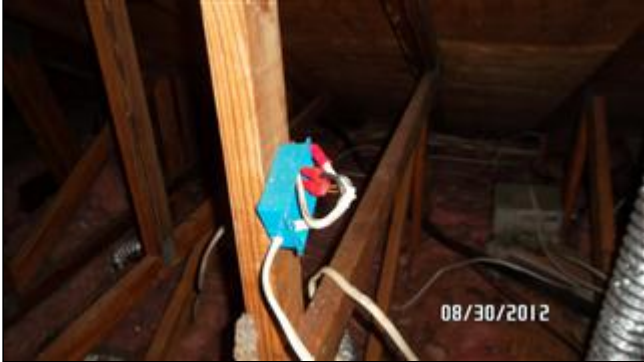
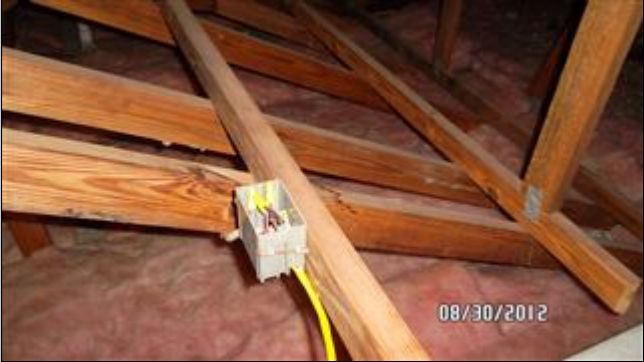
There are multiple junction boxes that are not covered in the attic. For safety purposed these should be covered.

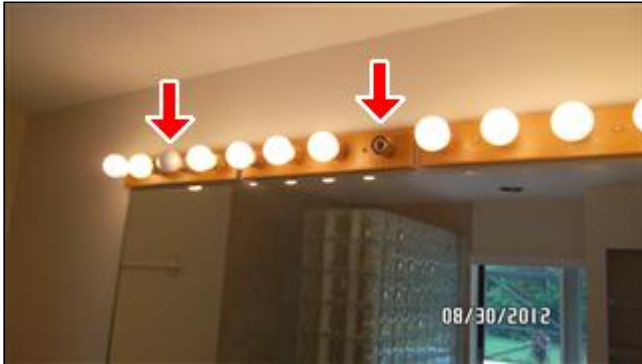
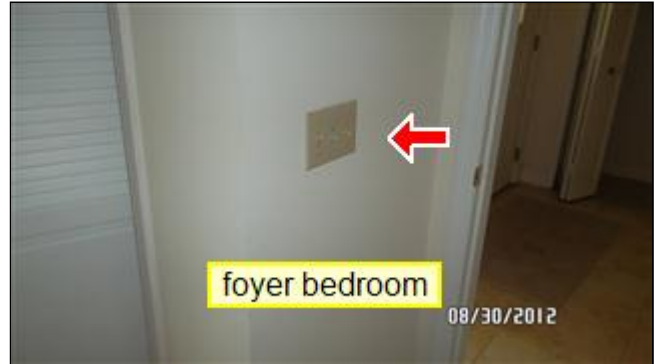
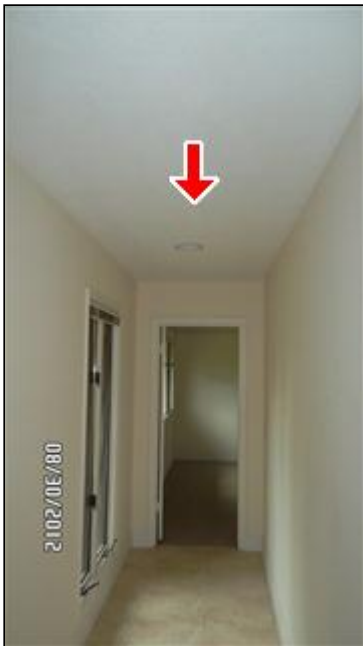
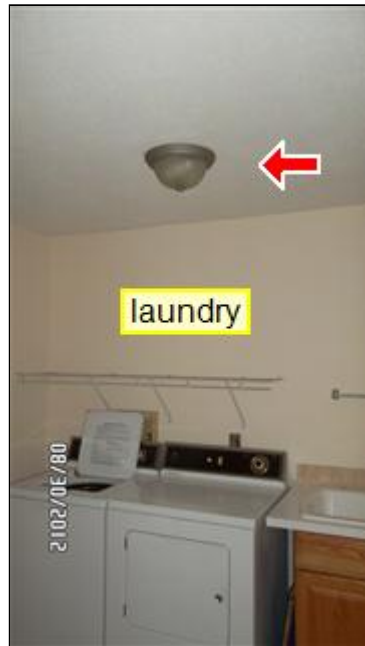
Master bathroom bulbs are missing or bad.

Unknown purpose for 2 of 3 switches. Usually this is to control an outlet but I was unable to determine.

The hall light is not working and neither is the laundry light or the light on the kitchen hood above the range.

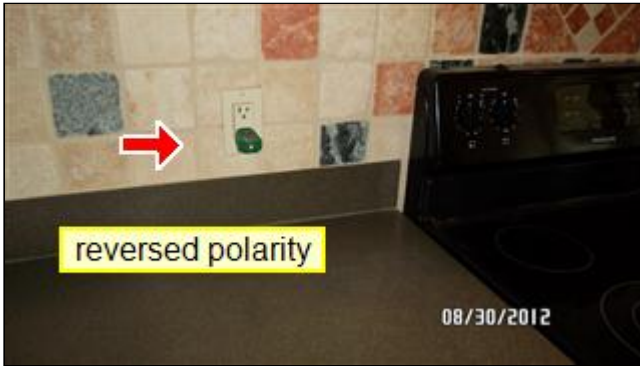
7.4 Picture 1

Outlet next to the range is reversed polarity so a GFCI will not work even if installed.

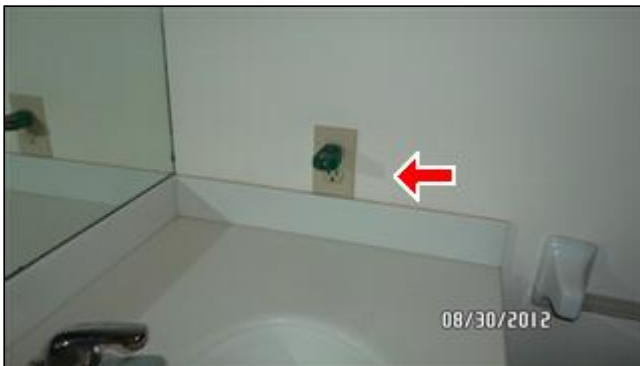
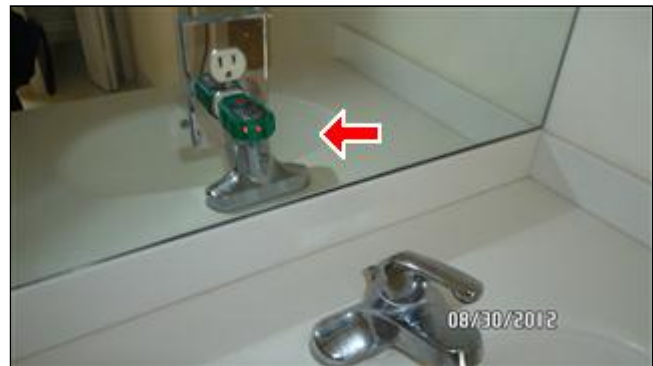
There are numerous duplex outlets both inside and out that are not protected by GFCIs. This is a shock hazard and should be addressed by a licensed electrician. Of particular note are the ones in the two bathrooms which have a GFI breaker in the garage and it works in the garage but not in the bathrooms because the outlets are wired improperly. Kitchen outlets are not protected either.
