# Inspection Report

**Property Address:**  
1230 Any Street  
Pleasantville FL 99999

**Home Check Inspection Services LLC**

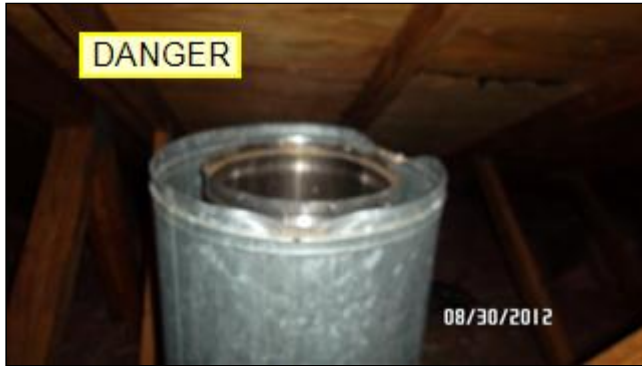
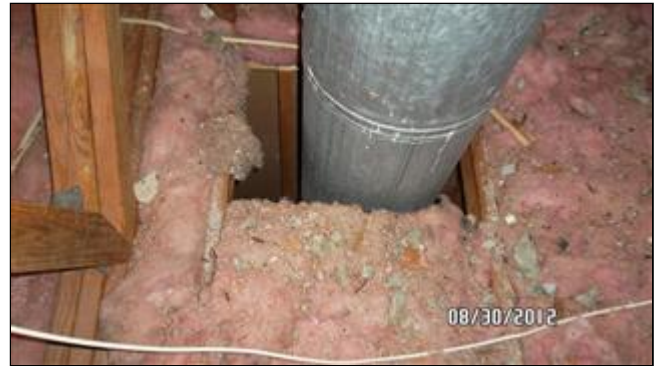
The gas fireplace chimney is not finished and is dumping into the attic which created a serious fire hazard. I suggest you remove the fireplace since the roof has been repaired.

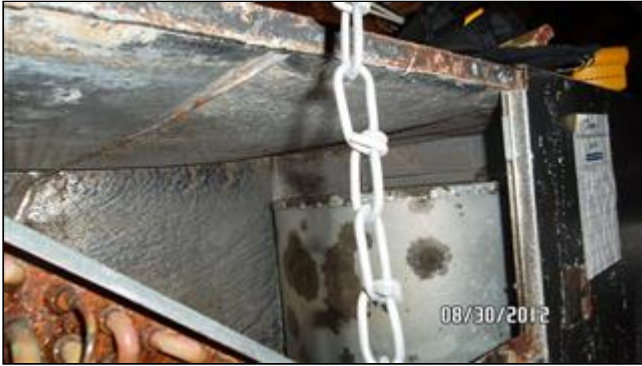
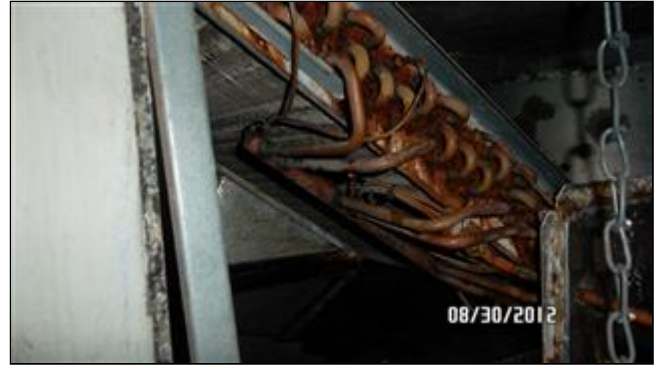
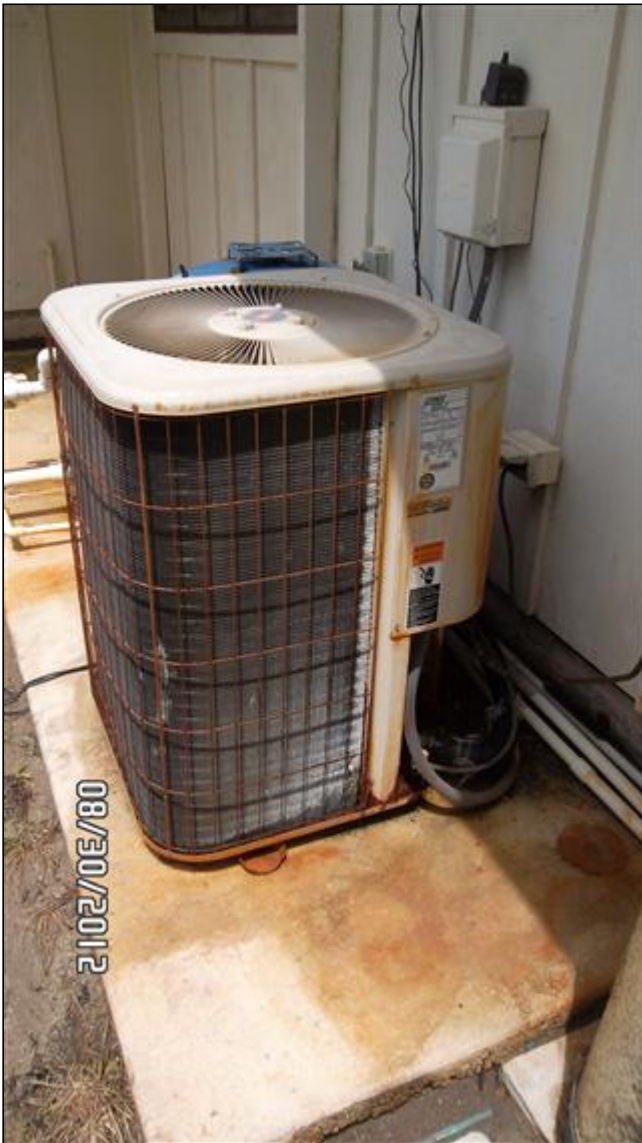
The A/C system as a whole is at the end of its life expectancy. You may wish to have the air handler cleaned since it appears to have been neglected for some time. There is also only about a 6 degree temperature differential between intake and output temperatures. I recommend you have at least one more servicing of the system if you plan to use it for a while.

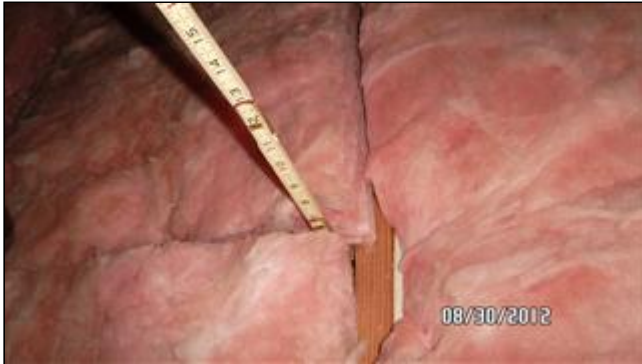
9.0 Picture 1

There is R19 insulation in the attic but a few spots have voids.

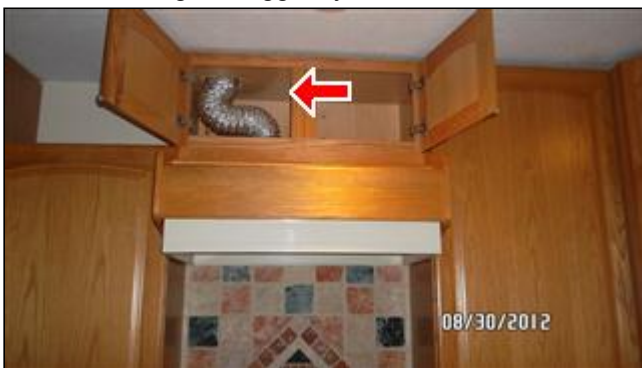
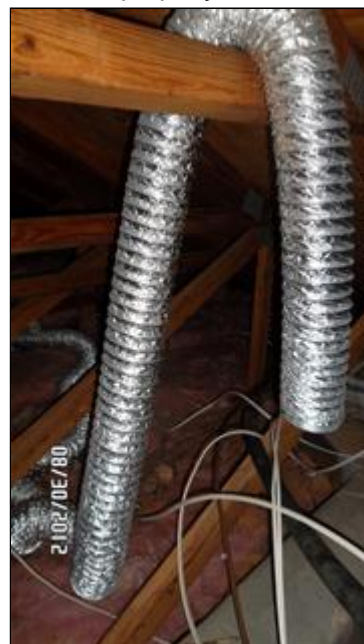
The range hood vent is not vented to the exterior, it is dumping moisture into the attic which will promote mold and moisture damage. I suggest you either not use it or have it vented properly.

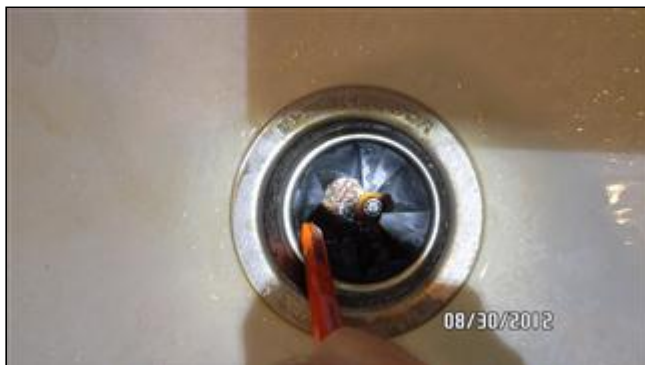
10.4 Picture 1

The food waste disposer is heavily rusted and has a minor leak in the mounting.

10.4 The food waste disposer is heavily rusted and has a minor leak in the mounting.
